June 15, 2023

**RE: Summary of 2023 Inspection, Town of Halifax Closed Landfill, VT DEC Facility SWID# WH280**

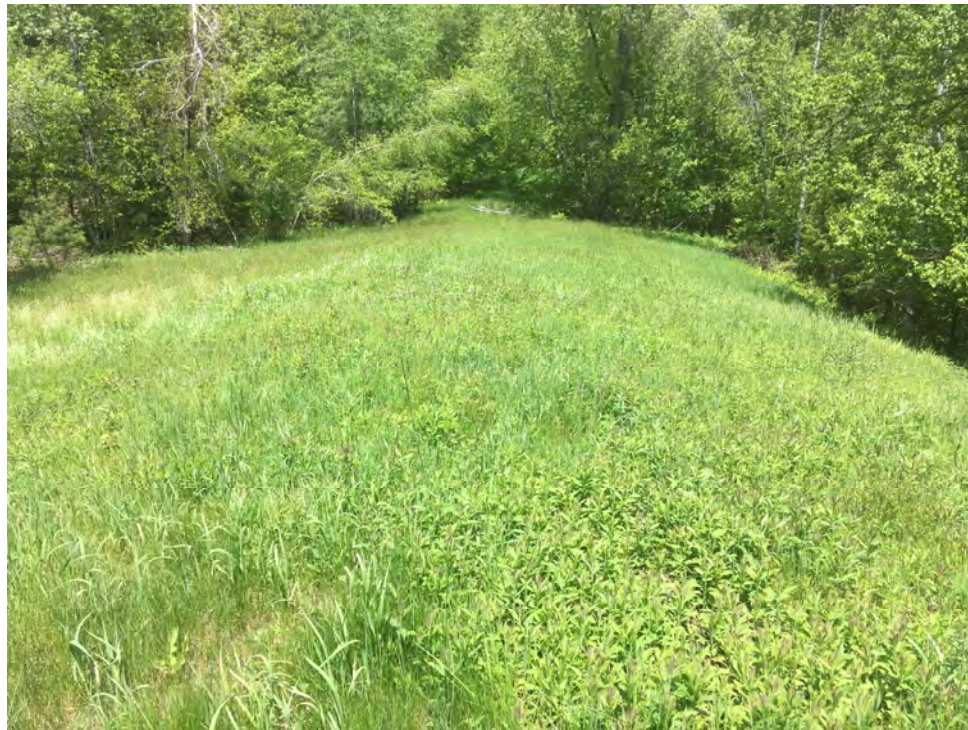
**Southern Landfill Area:** The landfill cap for this area was observed to be in good condition overall with no major erosion or slumping. All sumac growth appeared to have been removed from this area.

Photo 1 (looking north): Southern Landfill Area in good condition with lush growth.

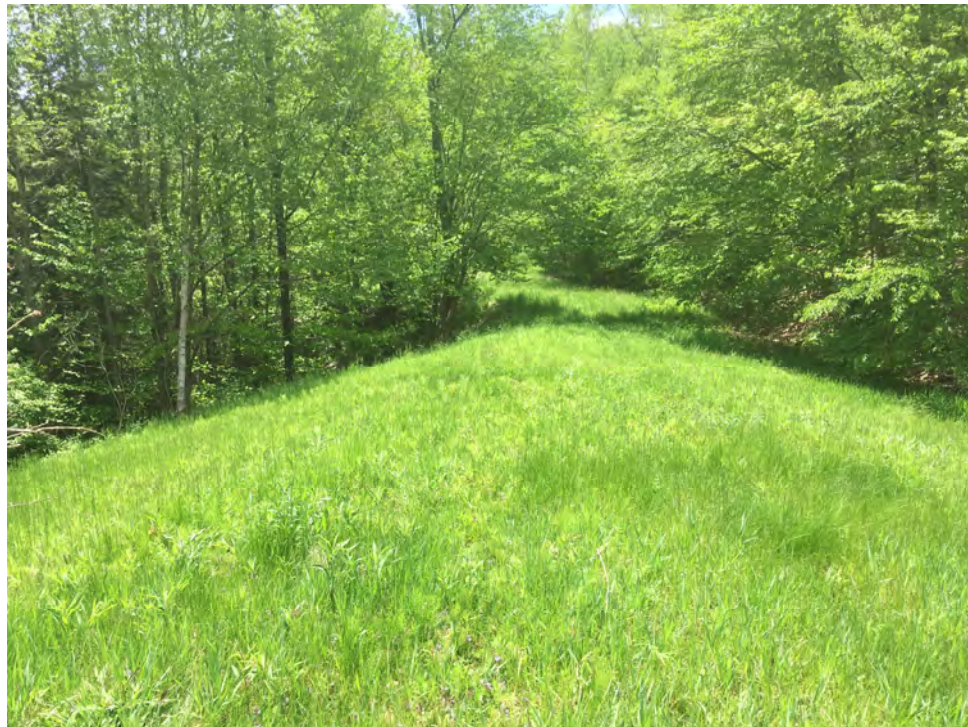
Photo 2 (looking north): Lower portion of Mid Landfill Area in good condition.

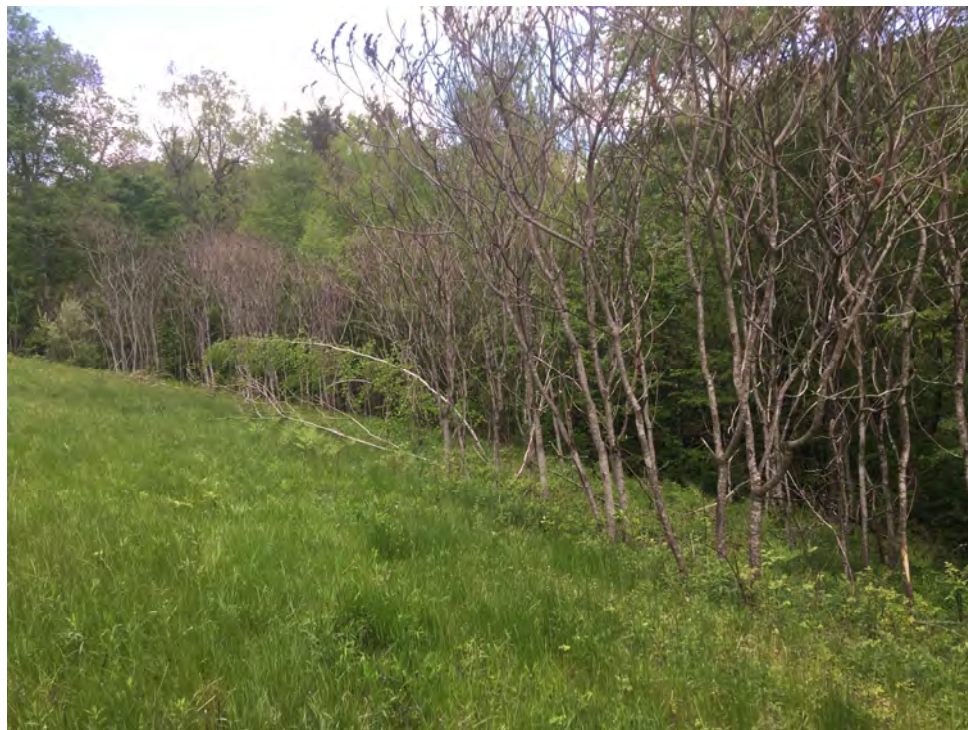
**Middle Landfill Area:** The middle landfill area is the largest of the capped landfill areas. The landfill cap was observed to be in good condition overall with good vegetative cover and no major erosion or slumping. The lower half of the western face of the landfill cap still has some established sumac that needs to be cleared. The concern is that the roots from this woody sumac vegetation may penetrate the landfill cap membrane, which would allow surface water to enter the landfill. In order to maintain a stable cap while also clearing the sumac, the following sumac clearing procedure is recommended:

Photo 3 (looking north): Middle Closed Landfill area in fair condition. Sumac and small trees need to be removed from the landfill cap.

1. Cut the sumac tree down to ground level using a chain or hand saw,
2. Do not remove the sumac roots from the landfill cap, as this will disturb and potentially destabilize the landfill cap,
3. After all of the sumac has been cut, brush hog the landfill cap at least once a year to cut any new sumac sprouts that grow up from the cut stumps,
4. Maintain a brush hogging schedule to prevent sumac and other woody species from establishing on the landfill cap.

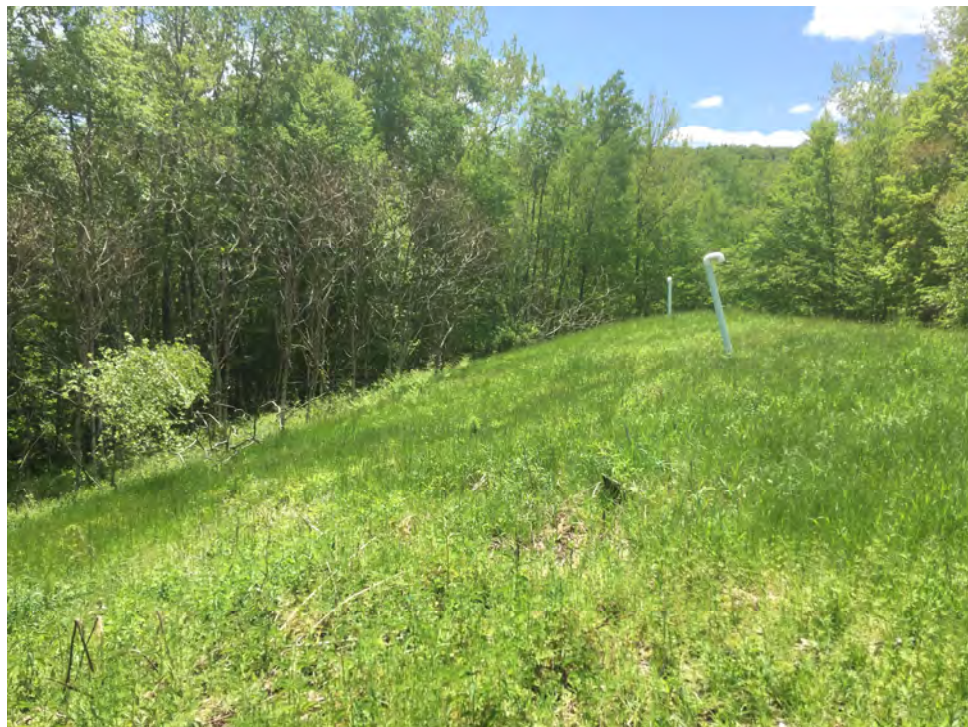
**Gas Control systems:** Three landfill gas vents are on the crest of the landfill. All three gas vents were observed to be in fair to good condition. The Town should inspect the gas vents when the landfill cap is brush hogged/mowed.

Photo 4 (looking south): Gas vents and top of closed landfill in fair to good condition.

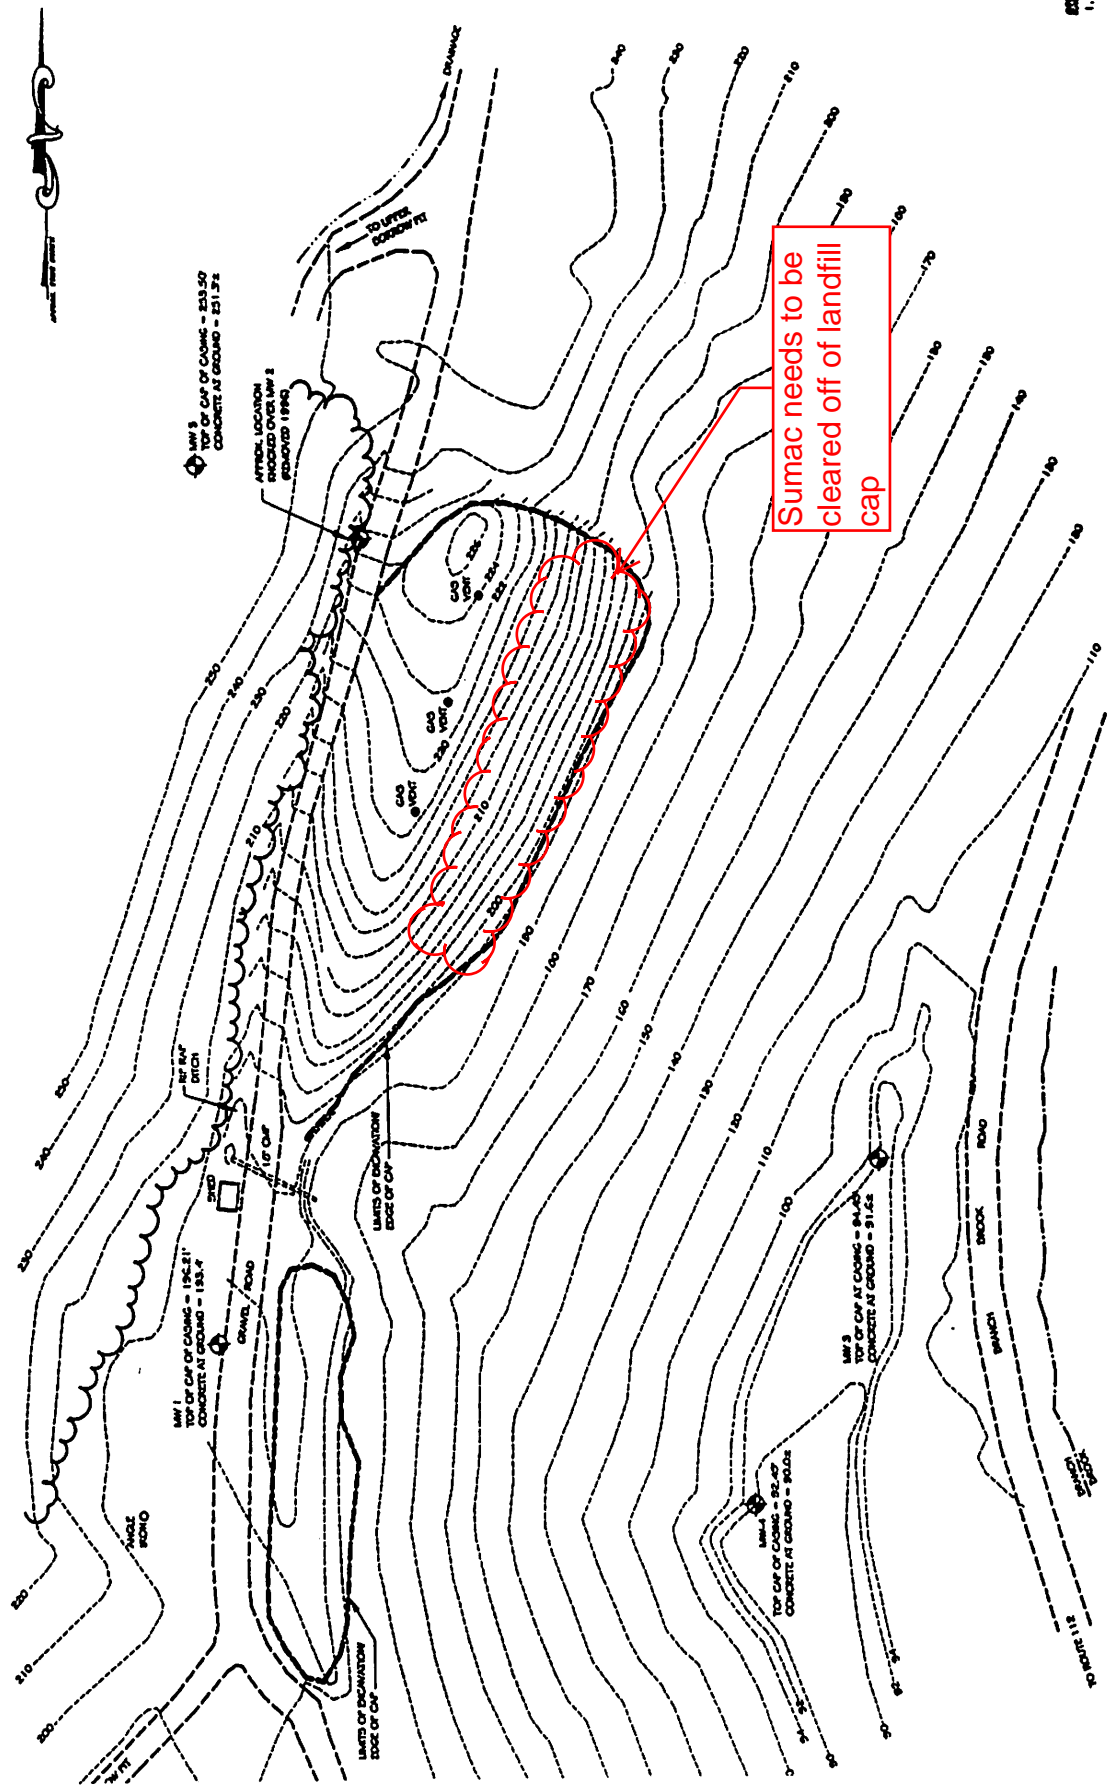
Red markups by KAS 6/15/2023

Sumac needs to be cleared off of landfill cap
